**LOWER ELKHART RIVER WATERSHED MANAGEMENT PLAN  
ELKHART, KOSCIUSKO AND NOBLE COUNTIES, INDIANA**

**23 December 2024**

**A PROJECT OF THE  
ELKHART RIVER RESTORATION ASSOCIATION**

**LOWER ELKHART RIVER WATERSHED MANAGEMENT PLAN  
ELKHART, NOBLE, AND KOSCIUSKO COUNTIES, INDIANA  
EXECUTIVE SUMMARY**

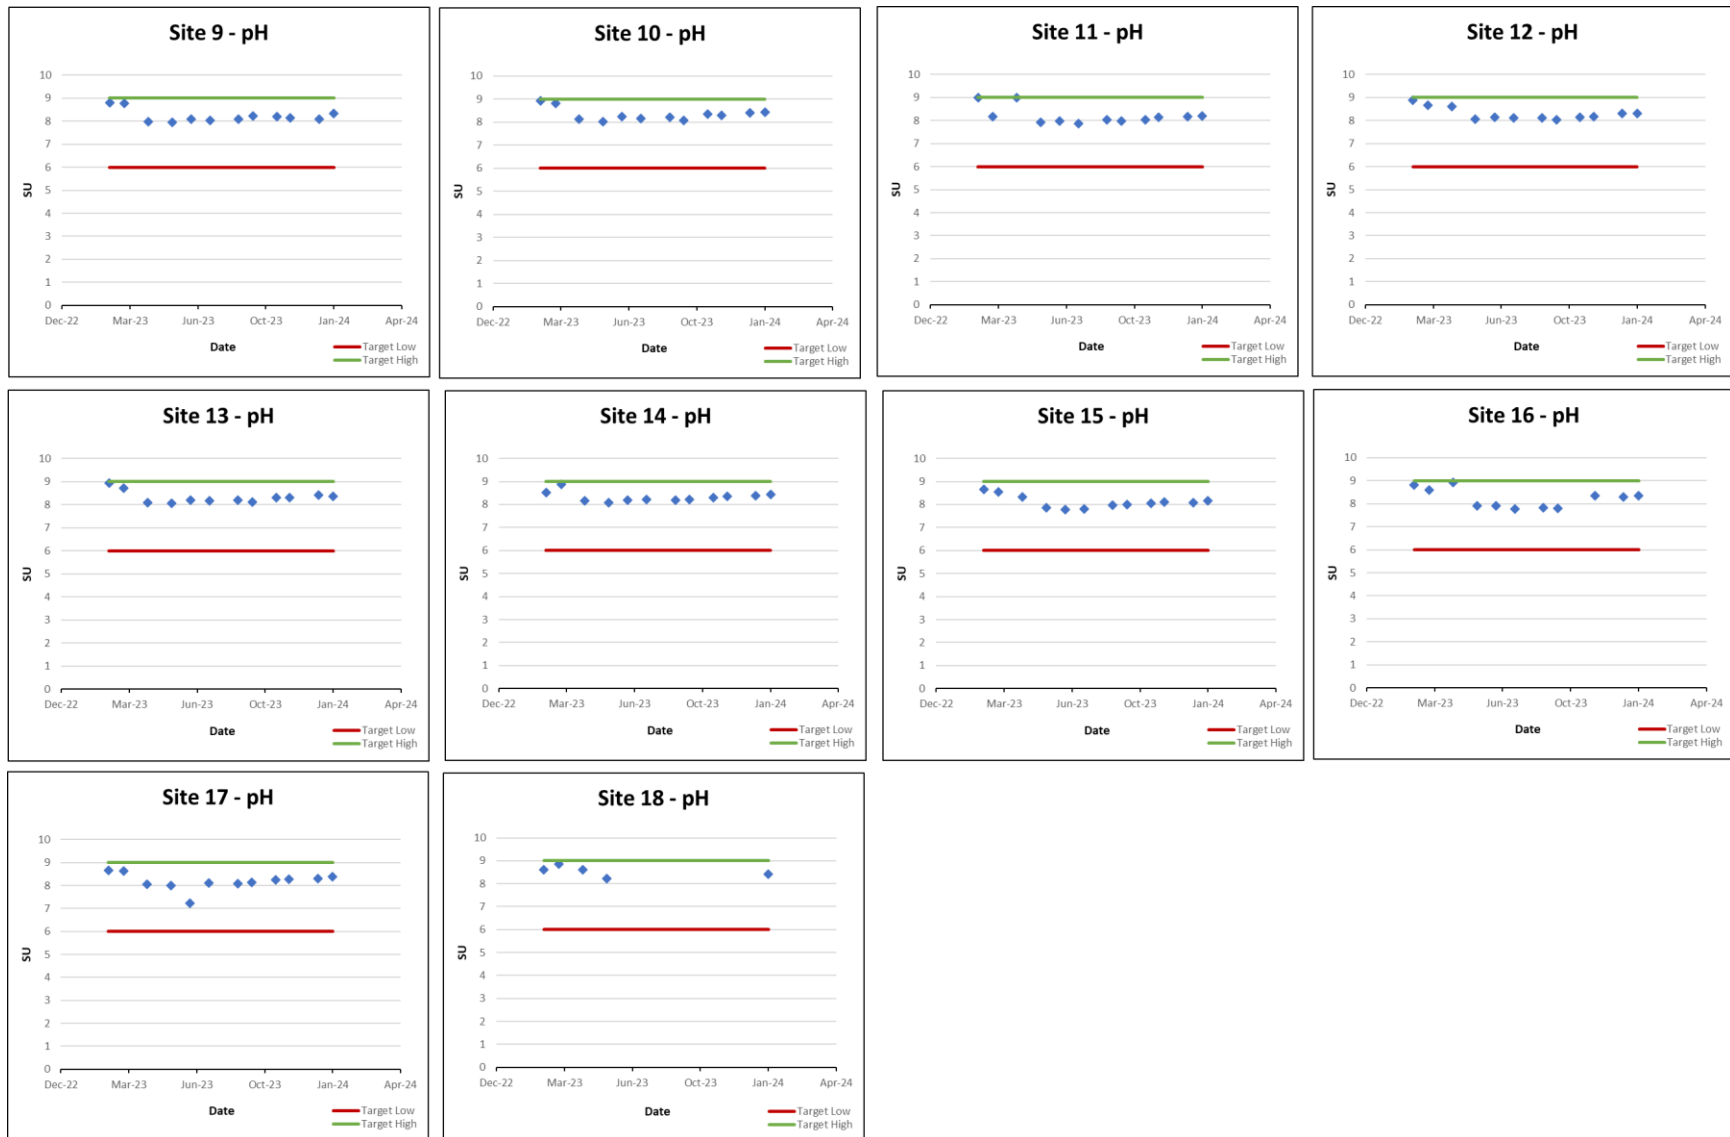
Figure 33. pH measurements in Lower Elkhart River Watershed sample sites from February 2023-January 2024. Note differences in scale along the concentration (y) axis.
